Will-Burt Product Service Bulletin

**Night Scan Chief Tower Lighting Product Line
Circuit Board and Wiring Harness damage**

**Bulletin # 0108
January 29, 2015**

Product Market Segment	Product Line	Models Affected
Commercial Lighting	Night Scan – Chief models NS 1.8 and NS 2.3	Ship dates from 2/14/11 through January 1, 2015

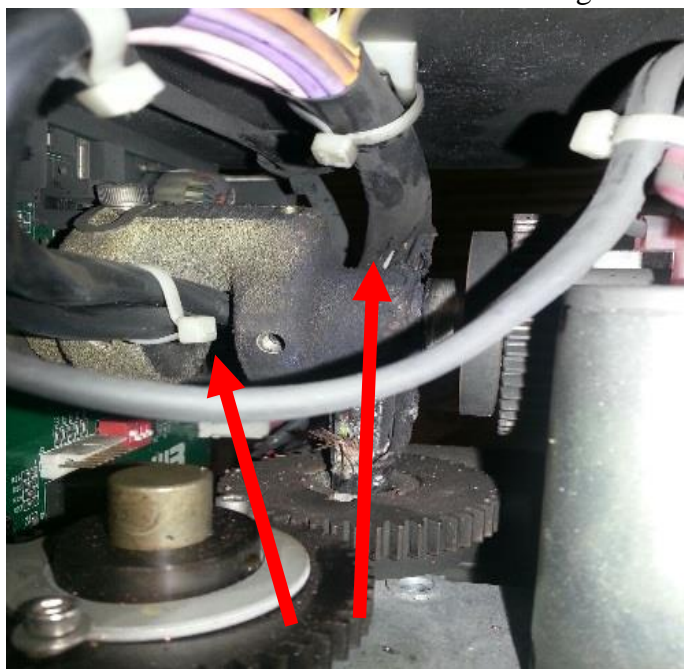
Figure B: RCP Wiring Through Coupling

In certain cases, wiring insulation within the RCP (Remote Controlled Positioner – Figure A) can come into contact with an abrasive surface (Figure B). Over an extended period of time, the abrasion could allow bare wires to come into contact with a metal surface resulting in an electrical short.

- Inspect the wiring bundle that passes through the coupling in the center of the RCP.
 - If no wear is evident on the wiring insulation or protective heat-shrink wrapping, no further action is necessary at this time. However, add inspection of the RCP wiring to your regularly scheduled maintenance routine of the Night Scan light tower.

- If wear is visible on the wire insulation, even if bare wires are not exposed, please take the following actions:
 - **Immediately discontinue use of product**
 - Call or e-mail customer service and request Chief RCP Wire Coupling Repair Kit Part # 5156901 free of charge
 - +1-330-684-5244 between the hours of 8am and 5pm EST Monday – Friday
 - rcowger@willburt.com
